Camp Sacramento Erosion Control Project – Five Years Later

**California
Resource Conservation Districts
2017 Annual Conference**
November 17, 2017

Paul Wisheropp, PE, CFM
Water Resources Engineer
Sacramento, CA

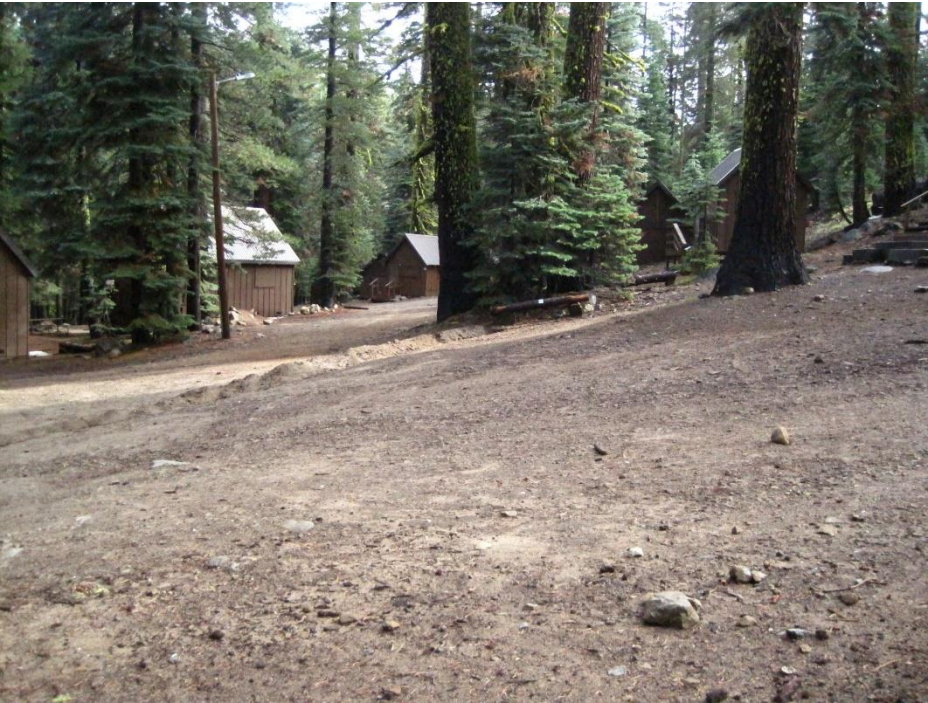
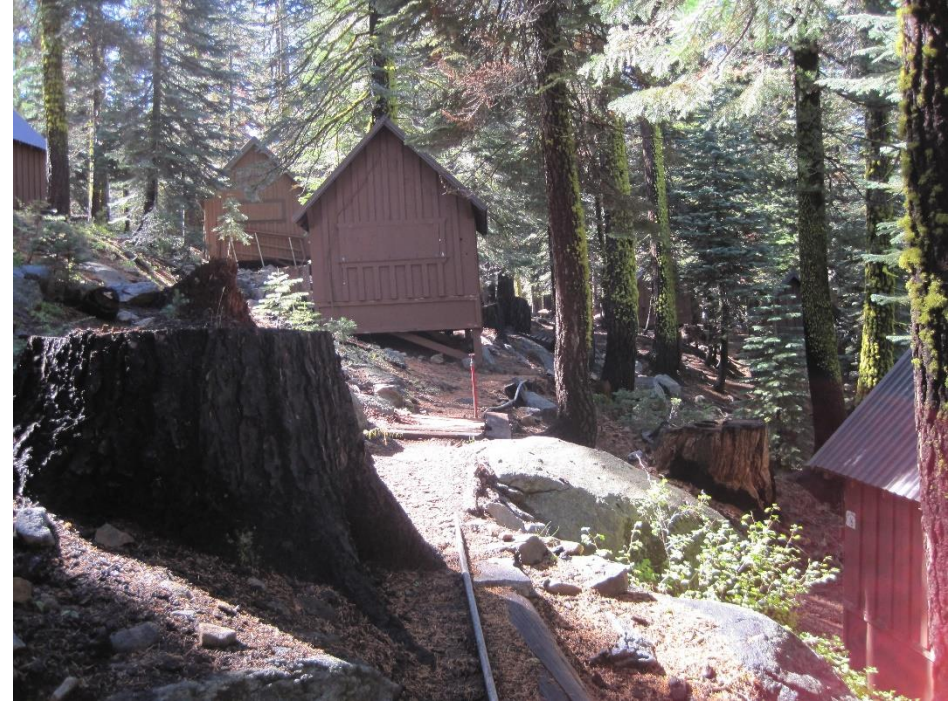
Problem Areas

- Riverside Hill
- Roads
- Parking areas
- Volunteer trails

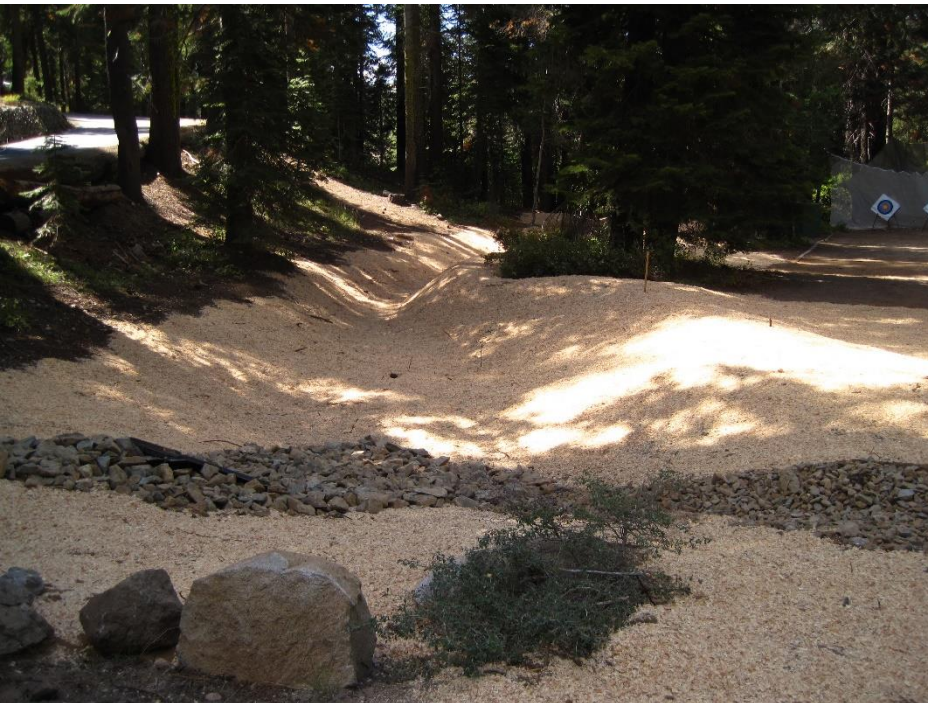
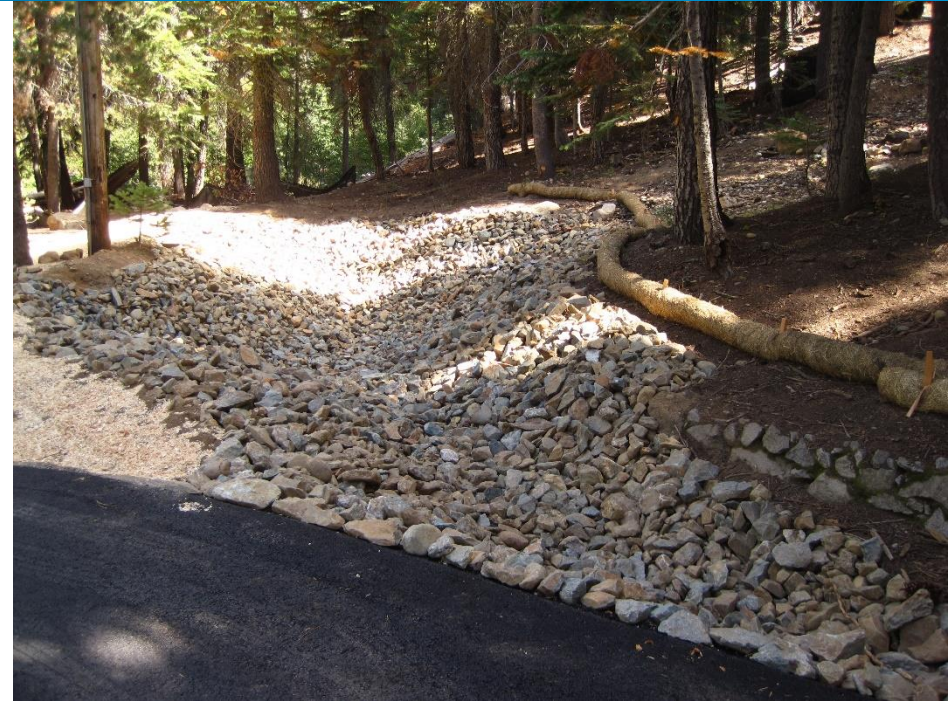
Basin Details

- Archery Basin outflows to floodplain
- 1.0' and 2.5' of dead storage in Lover's Leap and Archery basins

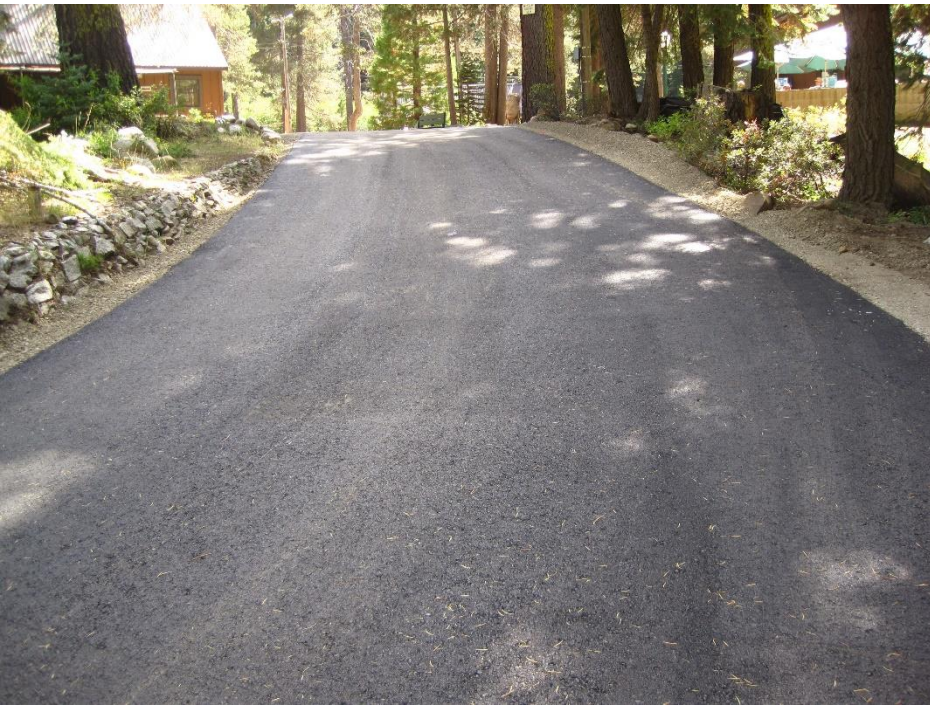
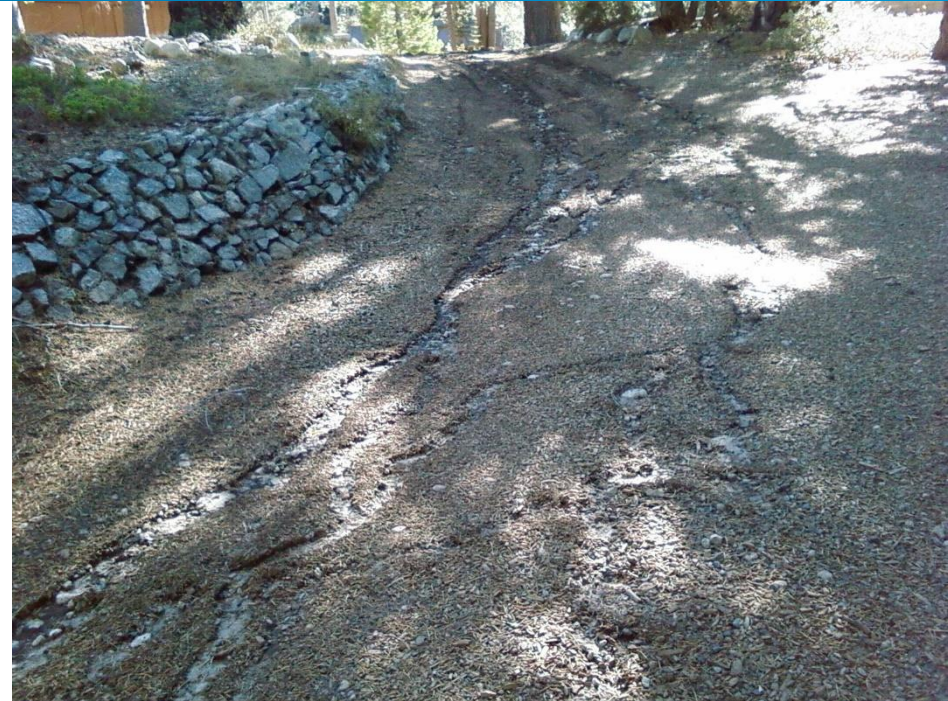
- Paved steep road section
- Previous site of erosion and sediment movement
- Culvert under road connects two basins

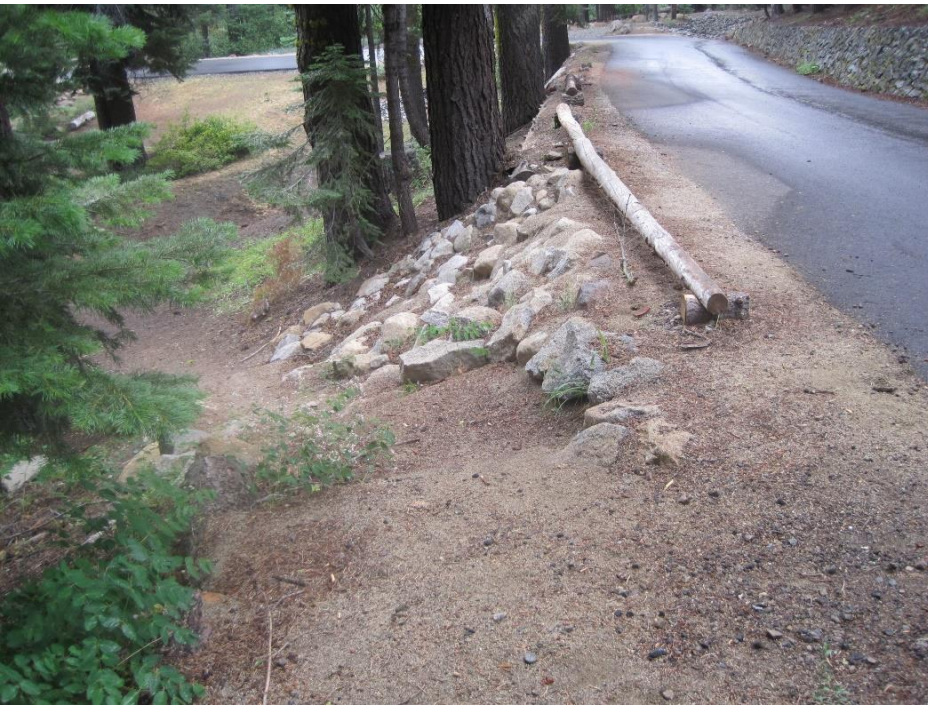
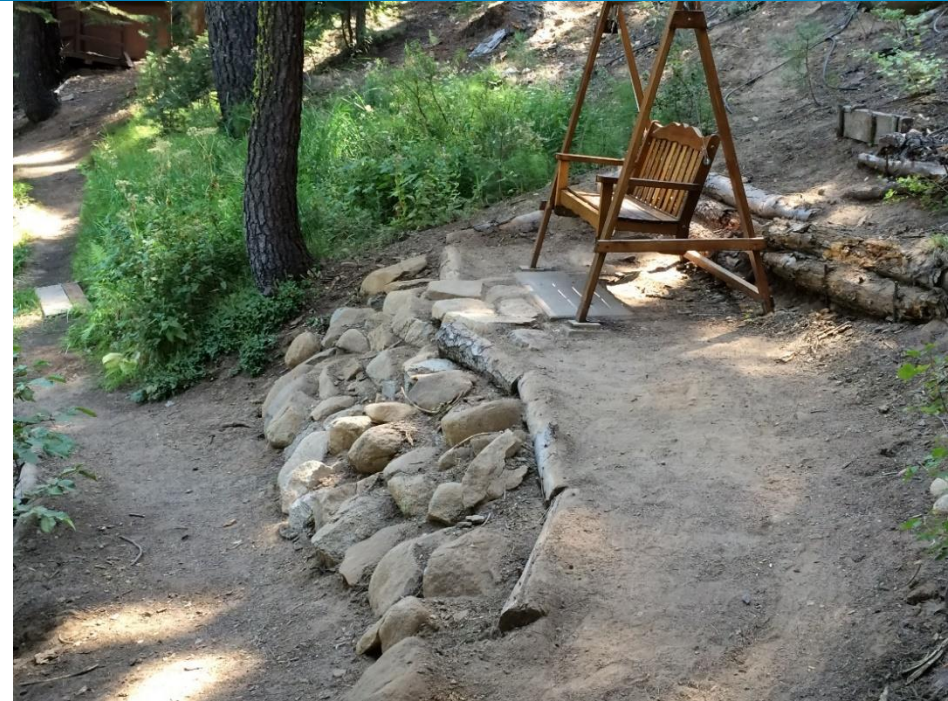
- Build rock slope protection
- Build rock-lined channel to connect camp with constructed facilities

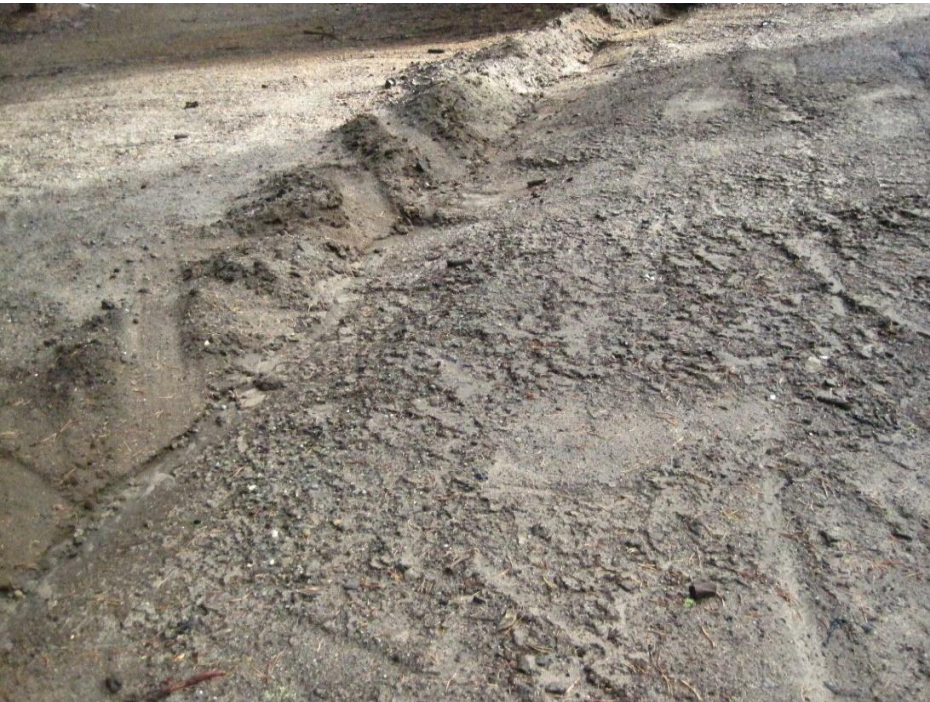
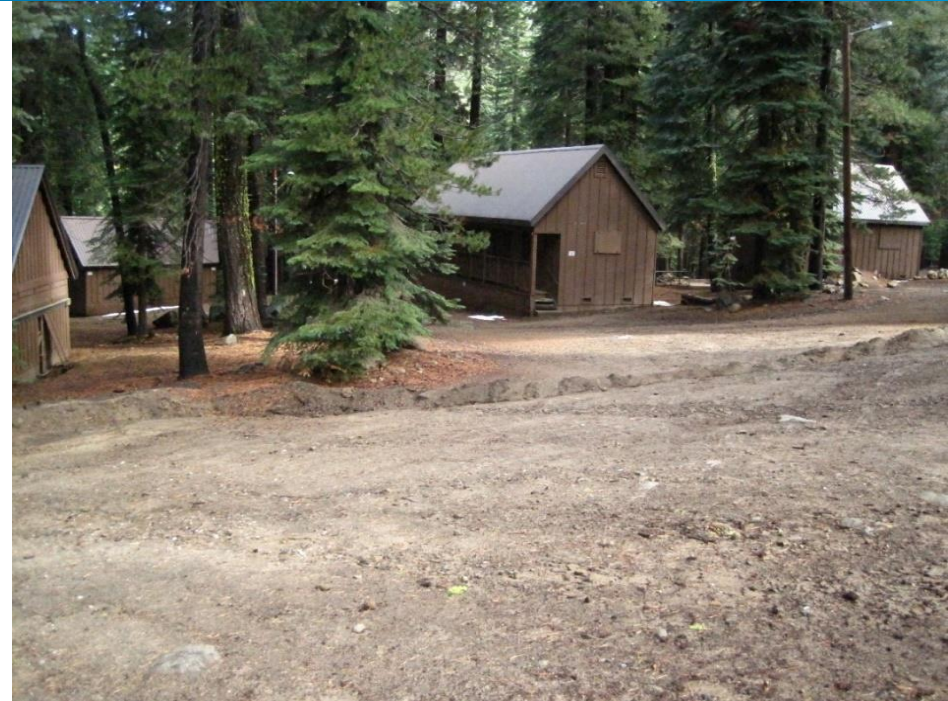
- Basins and control berms created in fall to capture winter runoff
- Taken down in spring
- Hydroseed test section in 2013

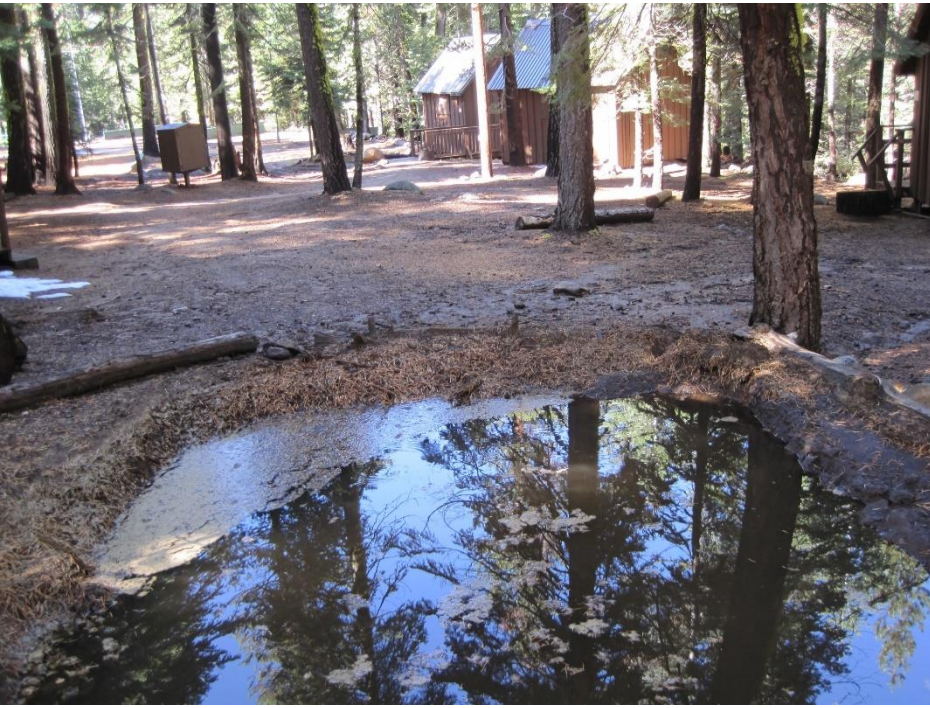
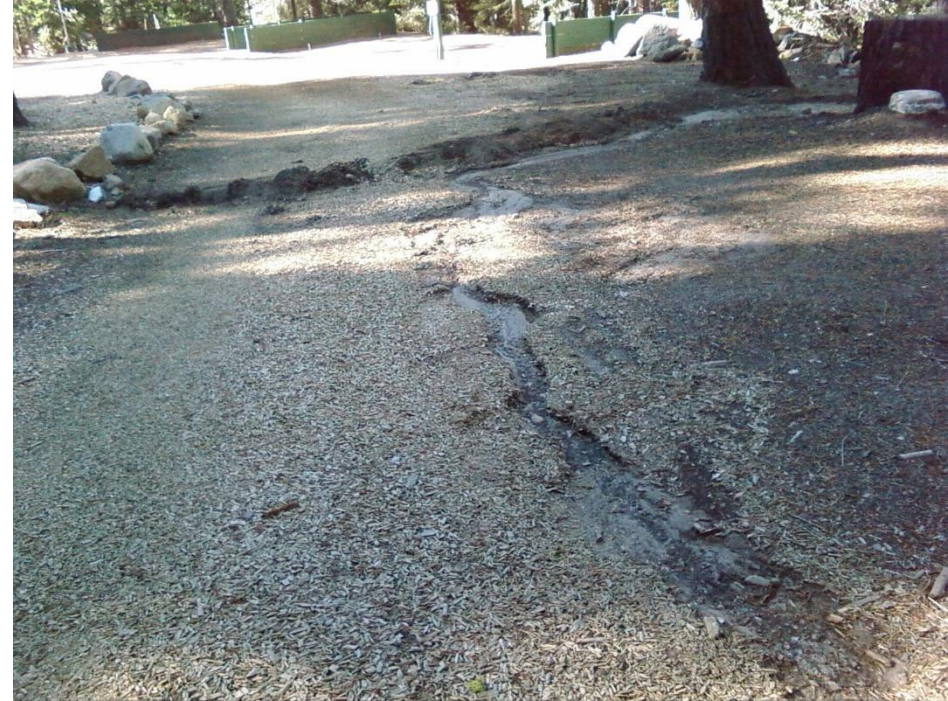
Design Approach

- Follow Lake Tahoe Approach:
 - Source Control
 - Hydrologic Design
 - Treatment

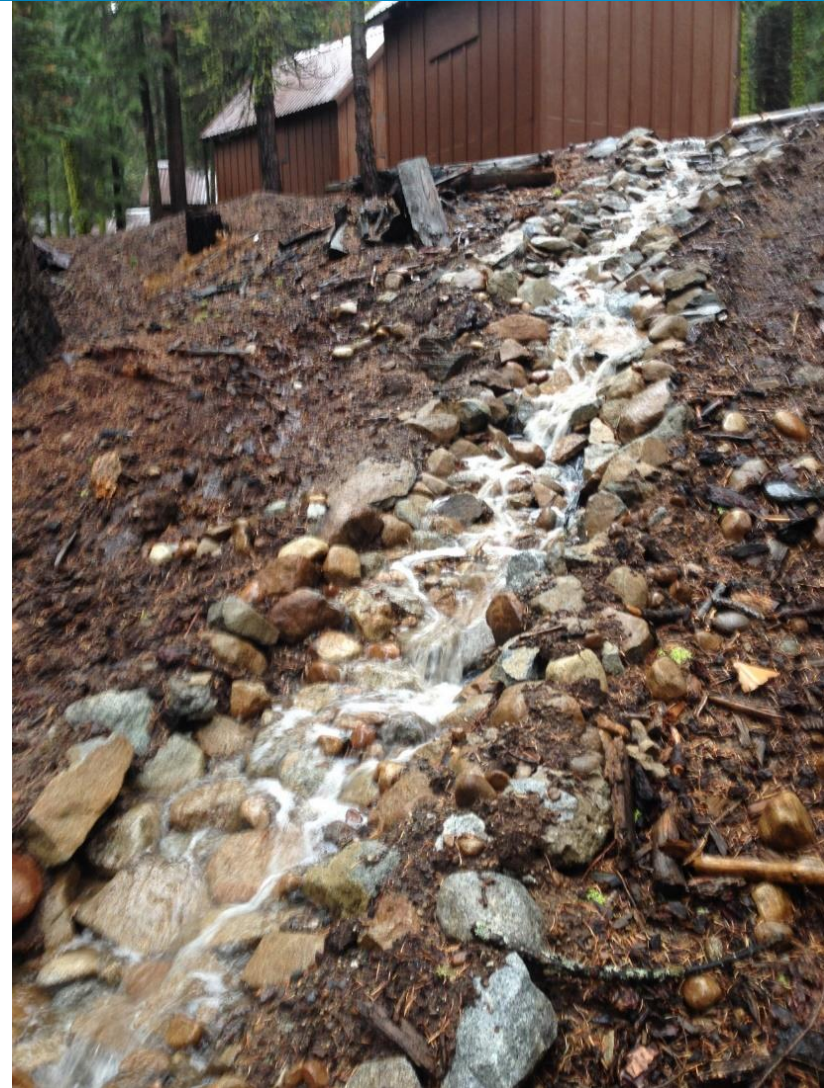
- Passive treatment (uncontrolled basins)
- Soil berms across roads break up sheet flow and control the runoff direction
- Upslope basins (in camp) lead to Constructed (Phase 1) basins
- Any outflow from Archery Basin goes to SOFAR floodplain
- Terrain barriers in floodplain prevent direct connection with river until high flood stage
- Entire system of berms and basins forms a treatment train

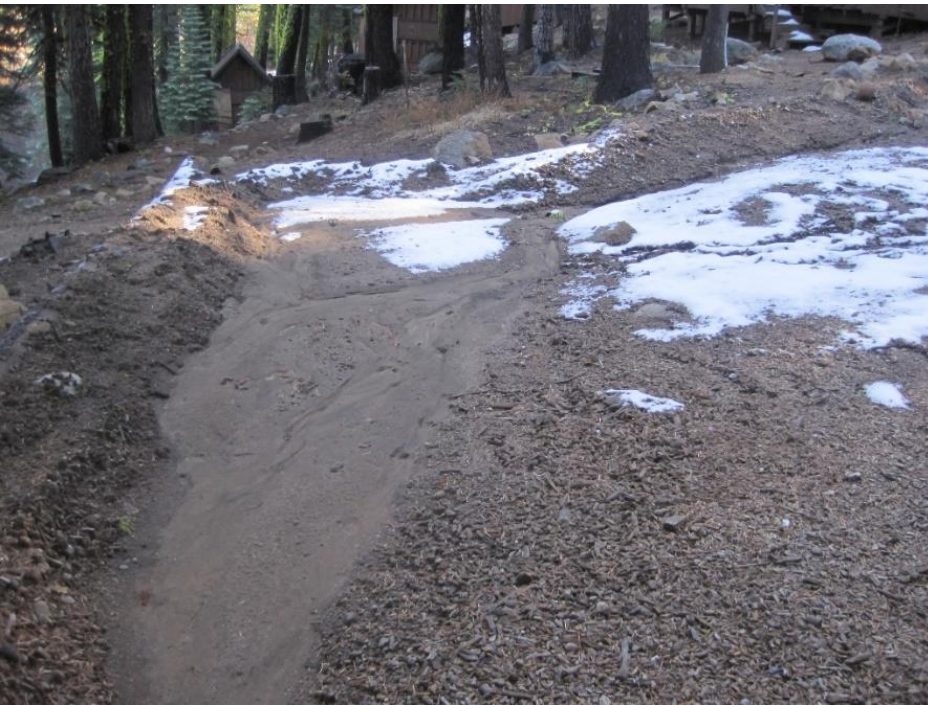
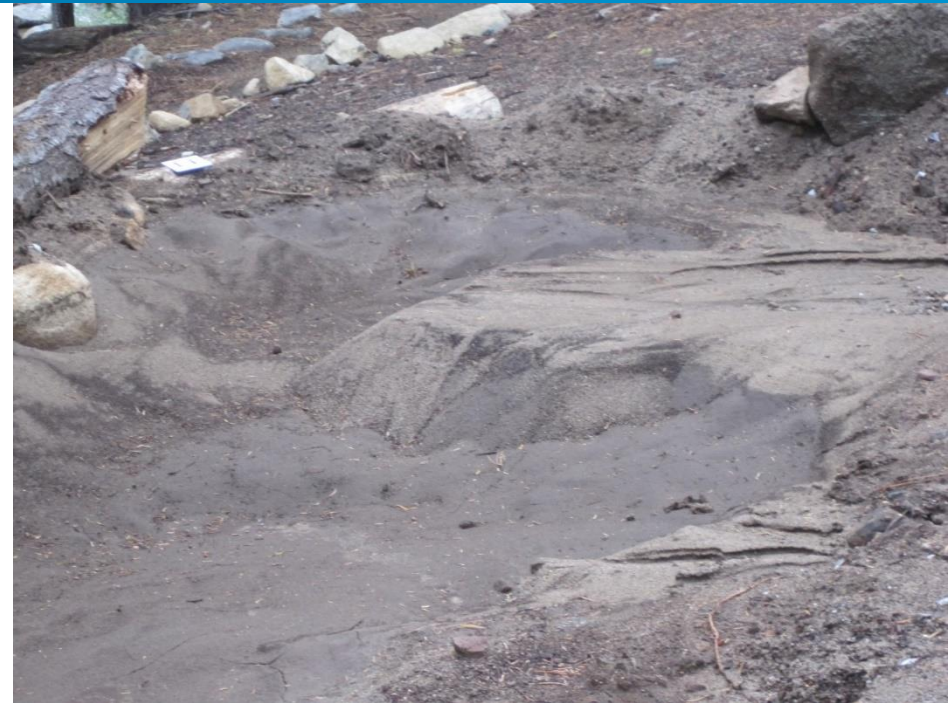
Typical Year

- First flush
- Spring snowmelt
- Major storm

Wet Year

- Long duration high intensity storm
- Back-to-back storms

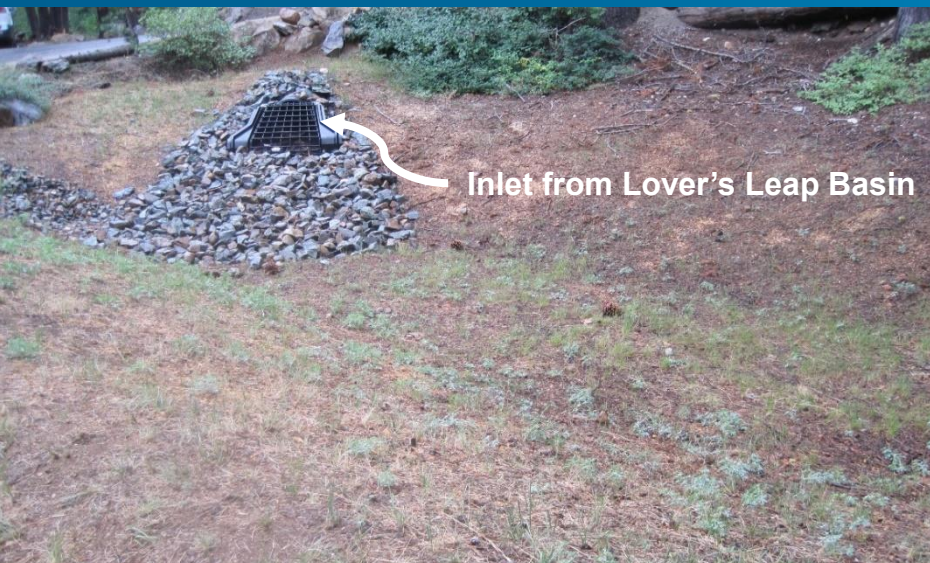
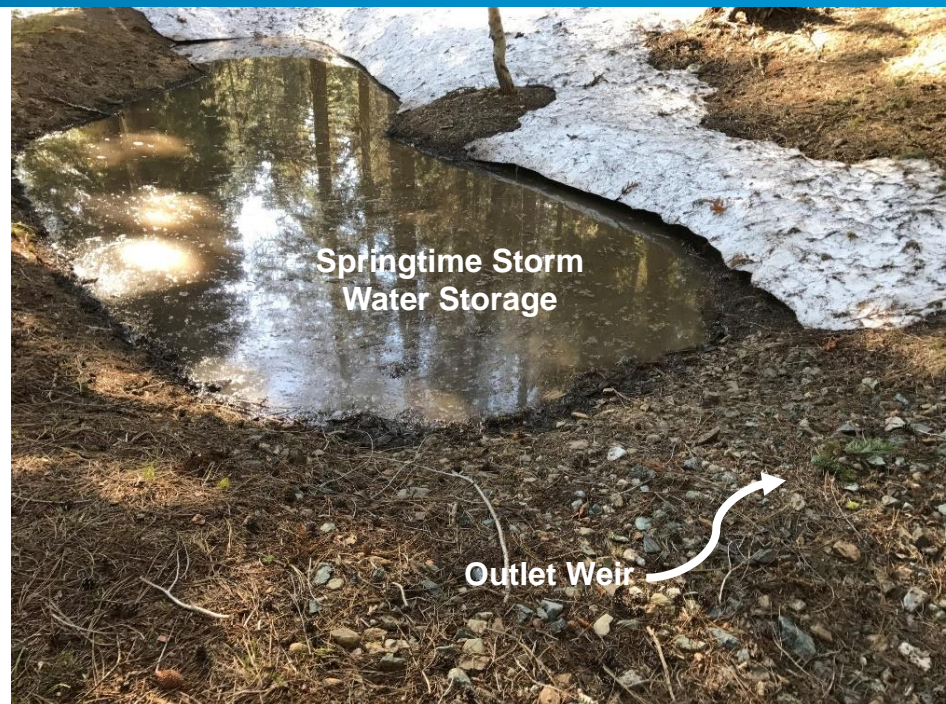
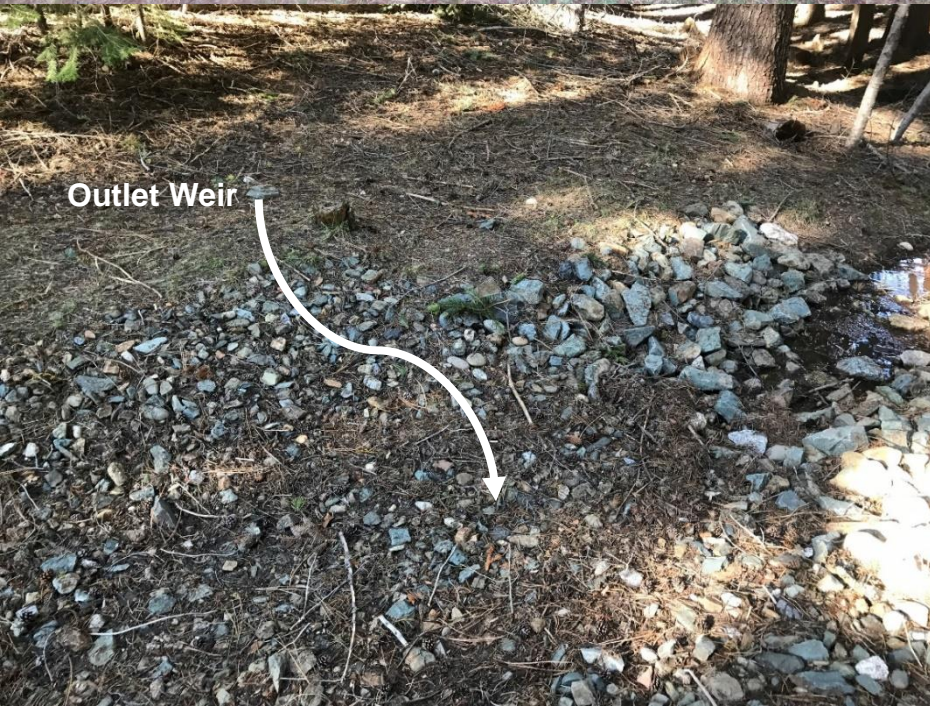
Treatment Train – Archery Basin

- Archery and Lover's Leap basins with water on 10/30/16 and empty on 11/2/16
- Archery Basin filled with water on 6/9/17 and near empty next day

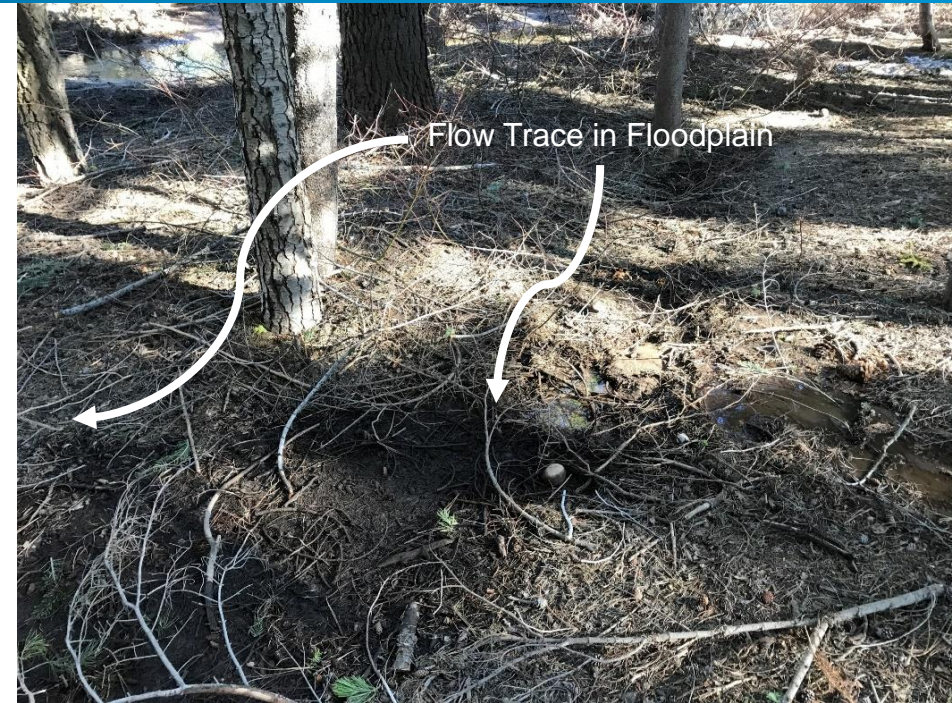
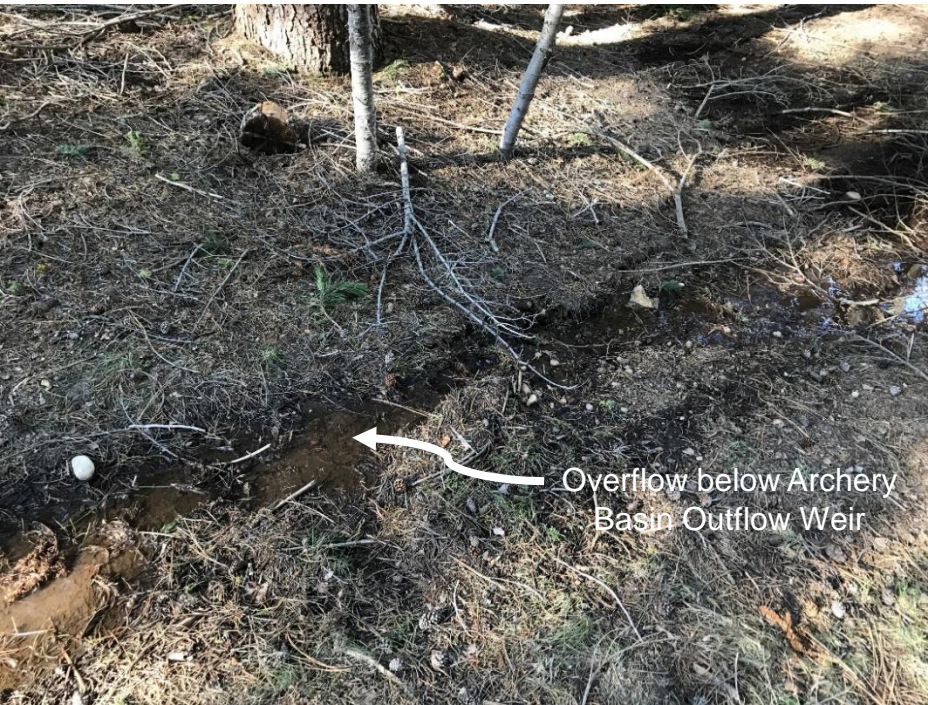
Treatment Train – Archery Basin Outflow

- Outflow to outer edge of floodplain
- Dense tree cover with extensive forest litter
- Flow paths are shown by disturbed litter
- No direct connection with SOFAR

- Multiple fill/spill of constructed basins with limited outflow
- Outflow carried very little sediment that dropped out before the river
- Archery Basin was a detention/retention basin. Water primarily left via infiltration. (2.5' dead storage)
- Outflow now going to river via subsurface rather than overland

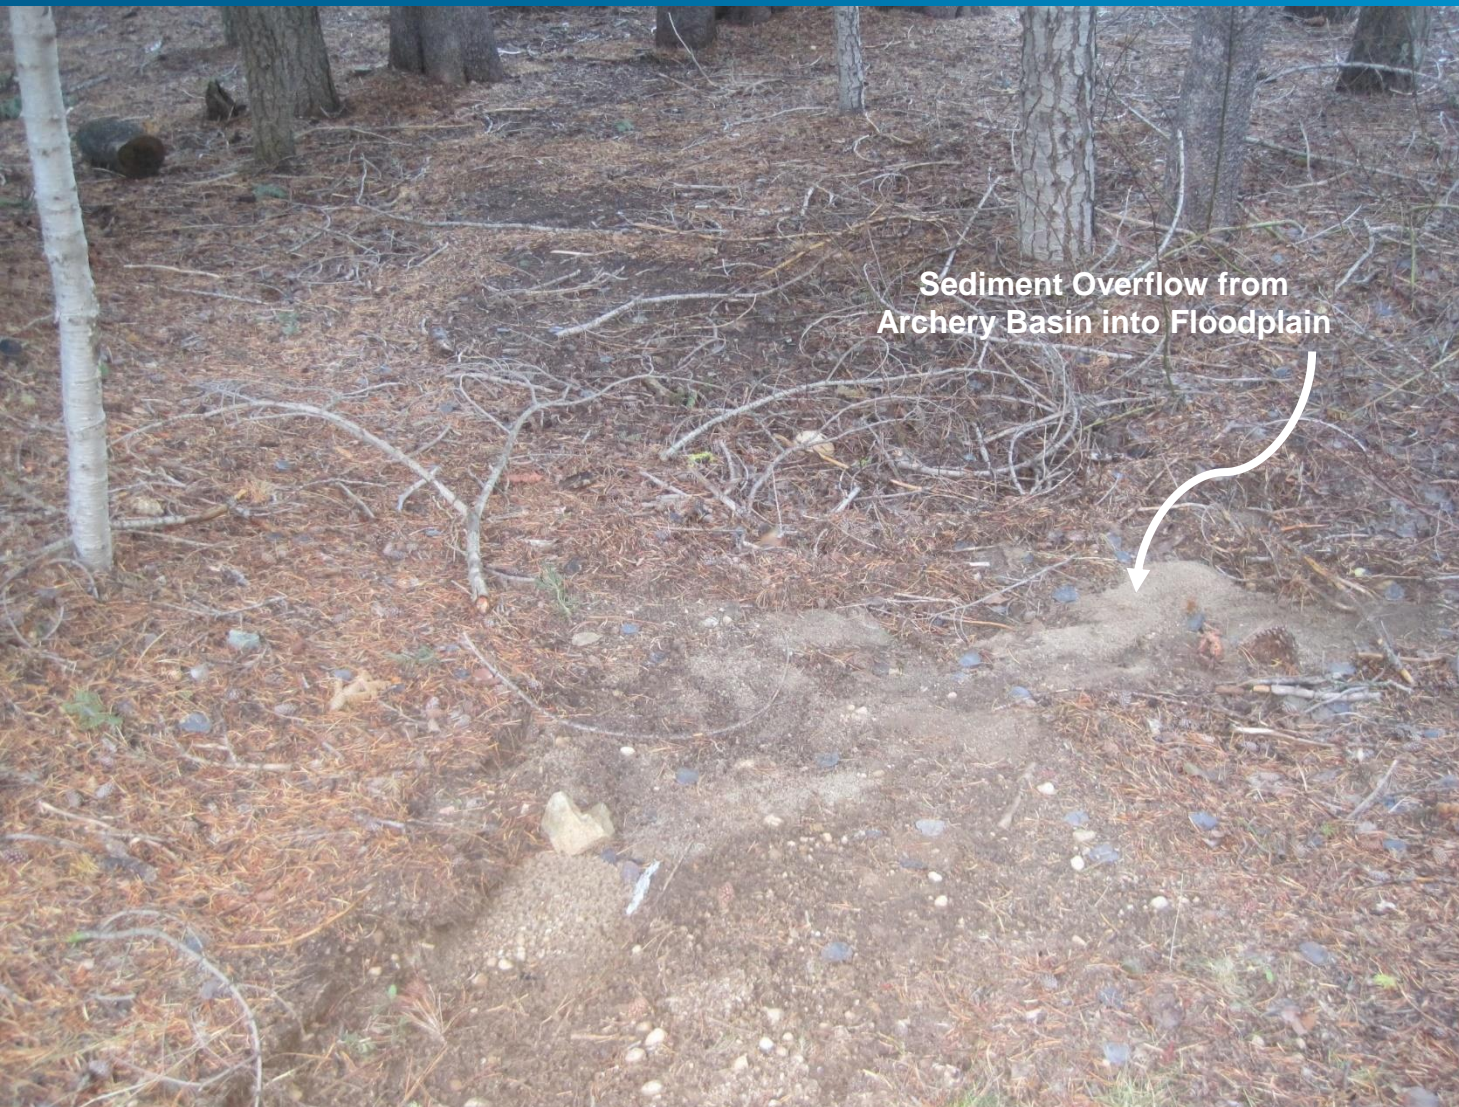
Treatment Train – Archery Basin

Overflow from Archery Basin

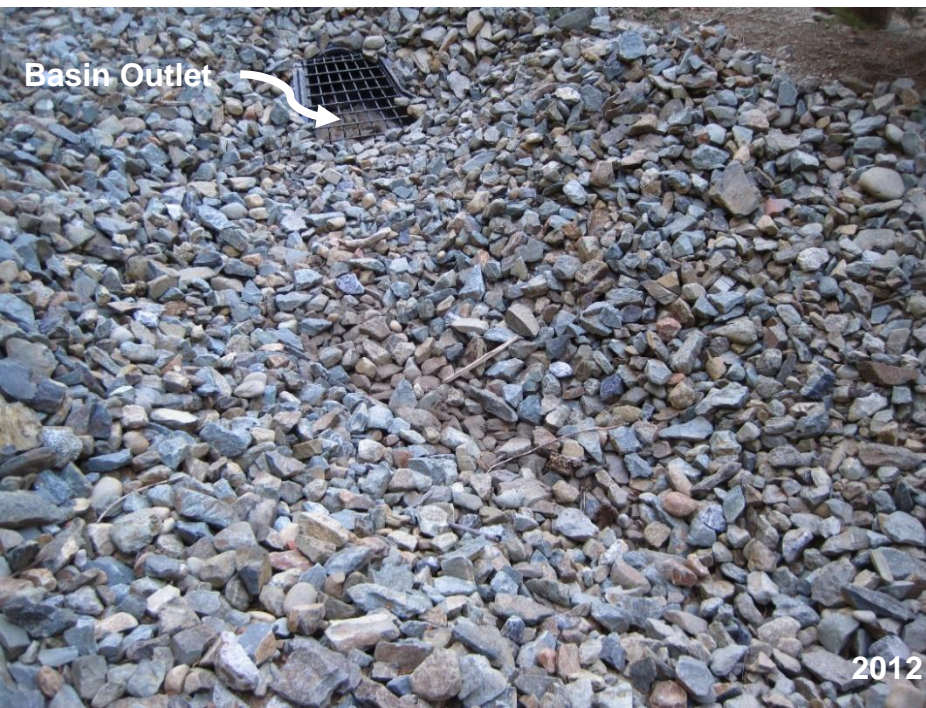
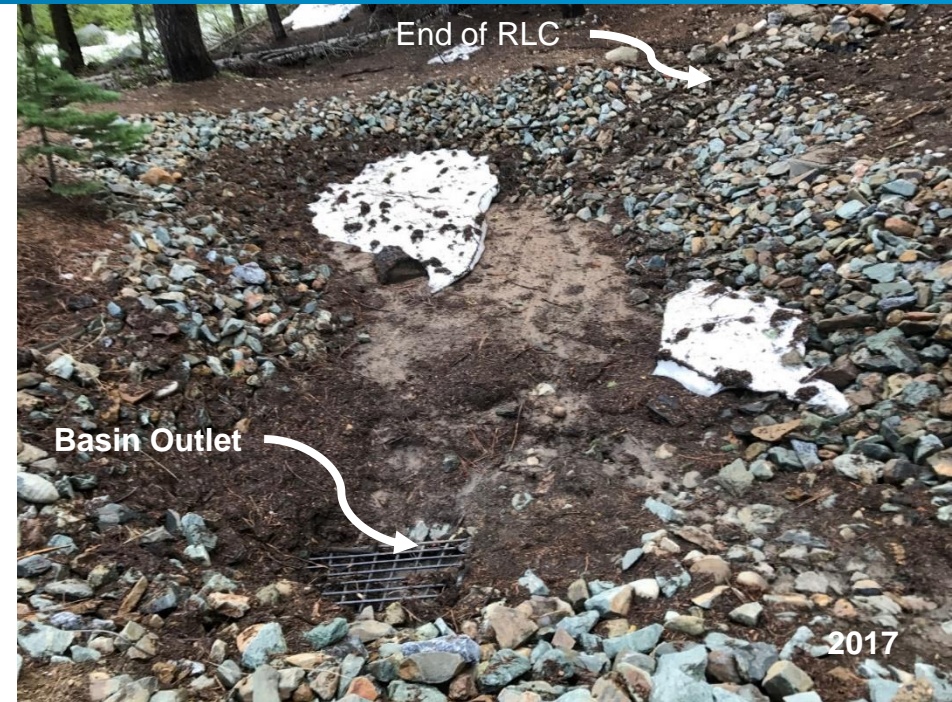
Collected Sediment-Lover's Leap Basin

- Limited stored sediment for first 4 years
- Organic matter collected on the road found in basin
- Sediment filled the dead storage extending above the outlet invert

Note: Photos taken from opposite ends of basin

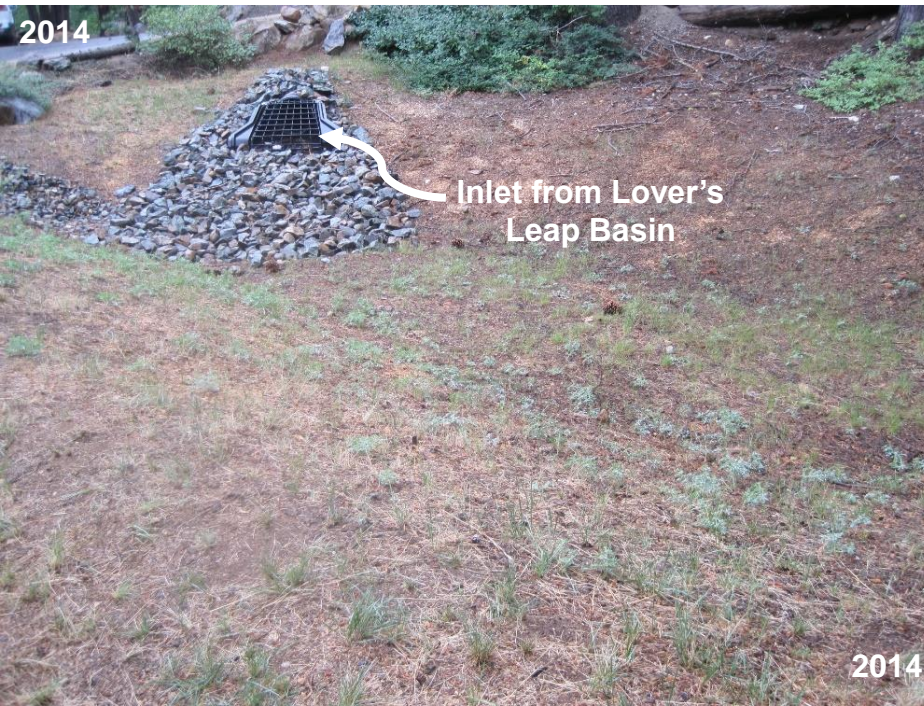
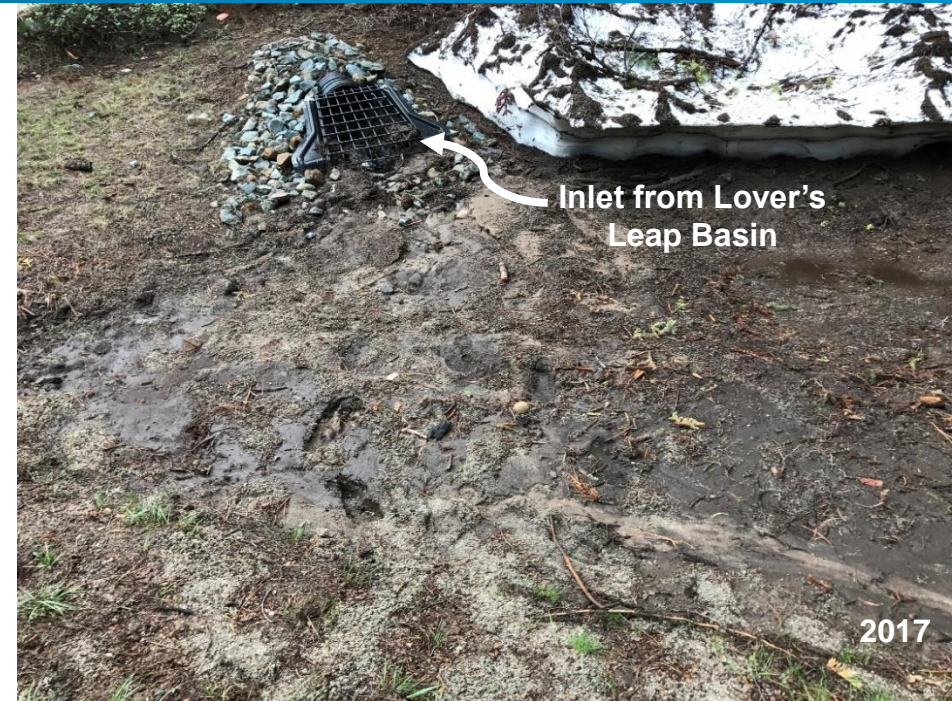
Collected Sediment-Archery Basin

- No stored sediment for first 4 years
- Organic matter from Lover's Leap Basin
- Evidence of overflow at outlet weir for several rainfall events

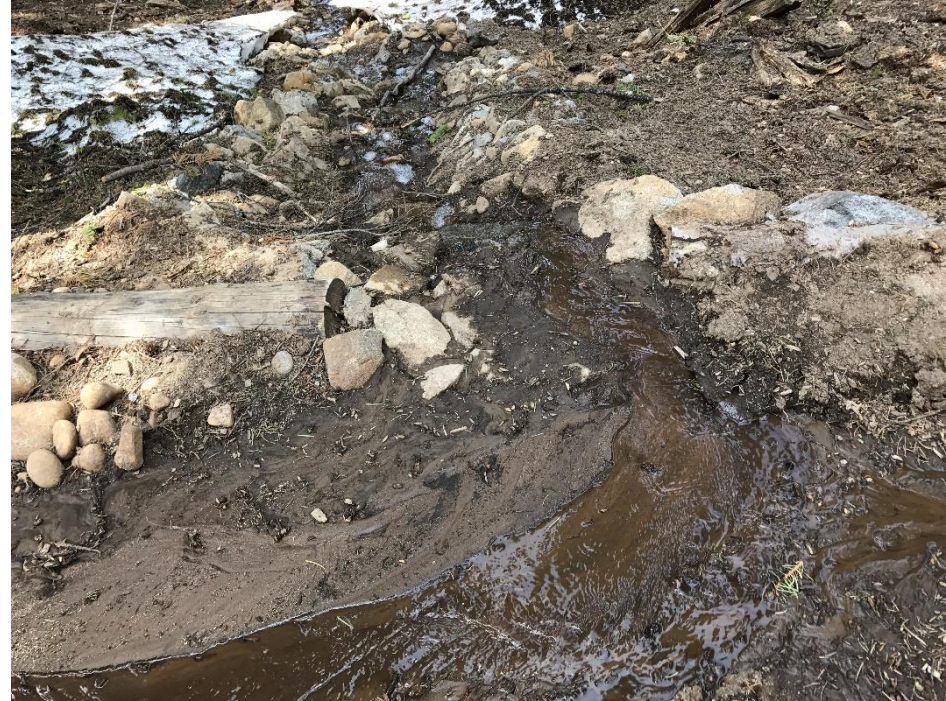
New Sediment – June 9 Storm

- Runoff-generating rainstorm
- Snow removal operations disturbed soil in camp
- Runoff was clear during snowmelt but turbid during rainstorm
